WASTE WATER PLANT

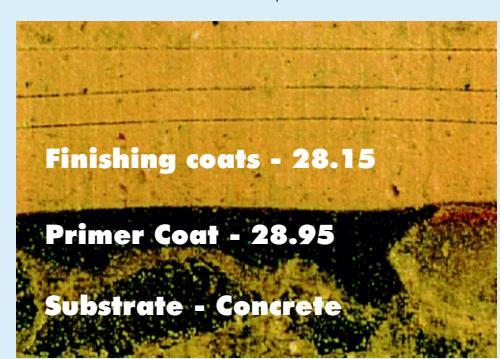
Right: a magnified section through a core sample clearly shows the four top coats and how the primer penetrates and smooths the substrate.
