BUND COATING

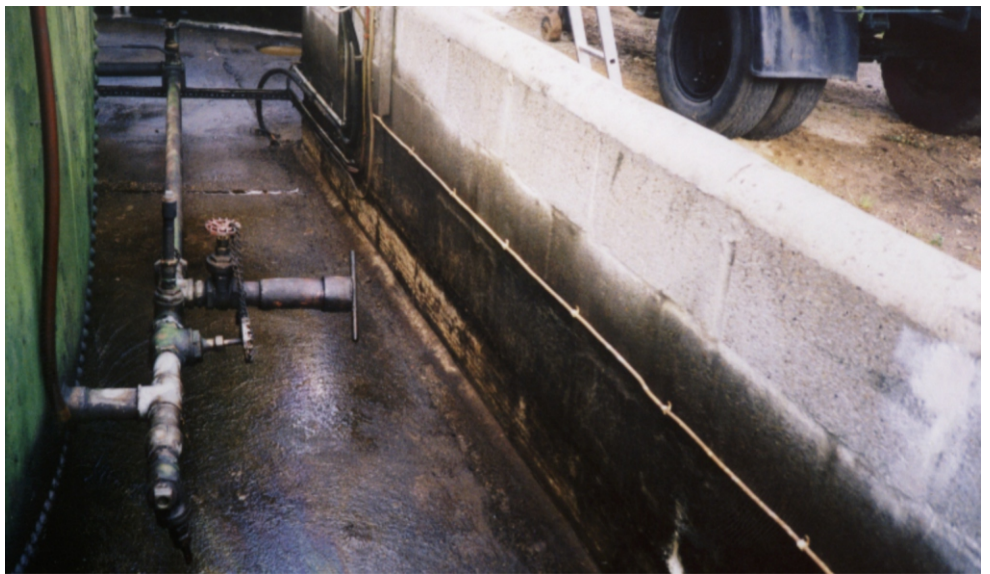
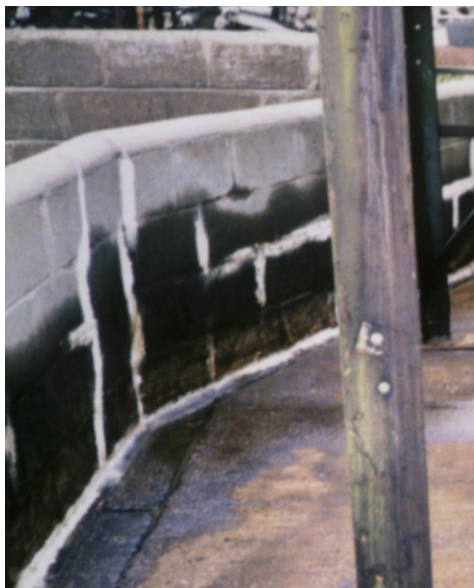
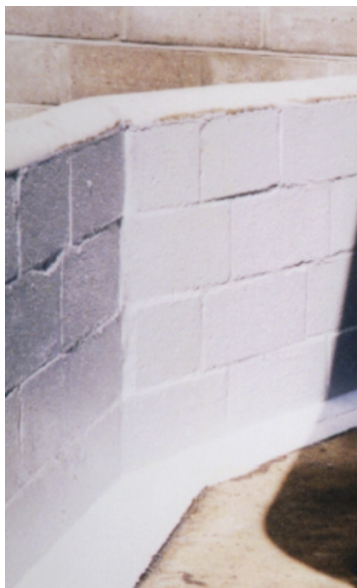
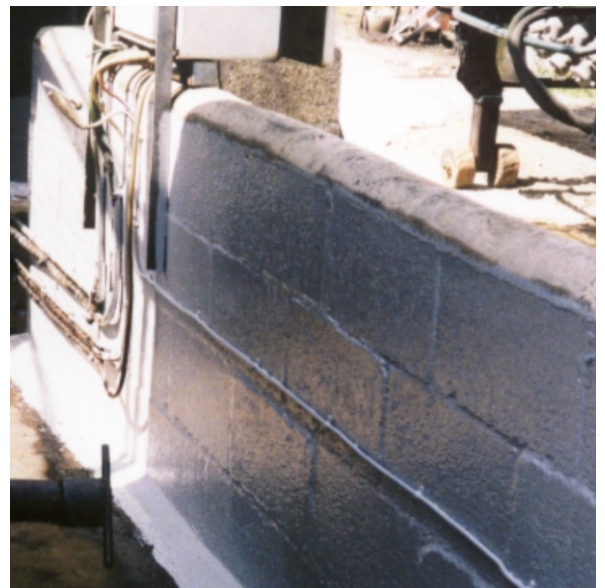
In this example, reconstruction was not an option because of budget restraints but, as the walls were entirely soaked in oil and no longer provided proper containment, a solution had to be found which prevented the oil spreading into the environment.

The walls were jet washed to remove as much surface contamination as

possible but, as the photo below shows, much remained both on and below the surface. Cracks and joints were repaired and then a sealing coat of Alocit 28.95 was applied followed by a finishing coat of Alocit 28.15 in standard gray.

Even the experienced contractor was amazed at the ability of Alocit coating products to penetrate through the oily

surface contamination and bond directly with the substrate, completely sealing the bund wall and preventing any further environmental hazard.
