WASTE WATER PLANT

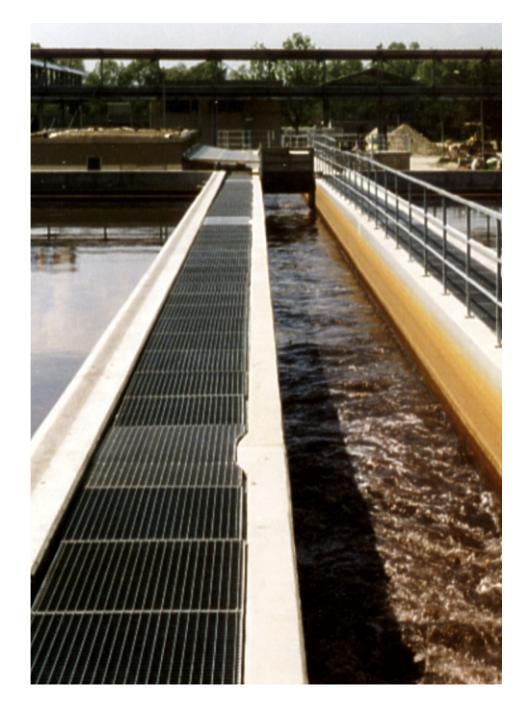
concrete. Exposed and corroded rebar had the rust removed and a mineralbased protection applied. As a result, the surface profile of the concrete substrate varied between an average around 60 mil / 3mm to as much as 160 mil / 8mm because of differing concrete quality and damage from chemical attack.

High-pressure water jets were used to remove failed coatings and damaged

The total DFT for the project was specified as 12 mil/600 microns on the walls and 20 mil/1000 microns on the floors, using the same Alocit coating

system that had been used thirty years previously: the primer was Alocit 28.95 and the top coats were Alocit 28.15. All coatings were hand-applied by roller.
